## PHOTOGRAPHIC PLATES

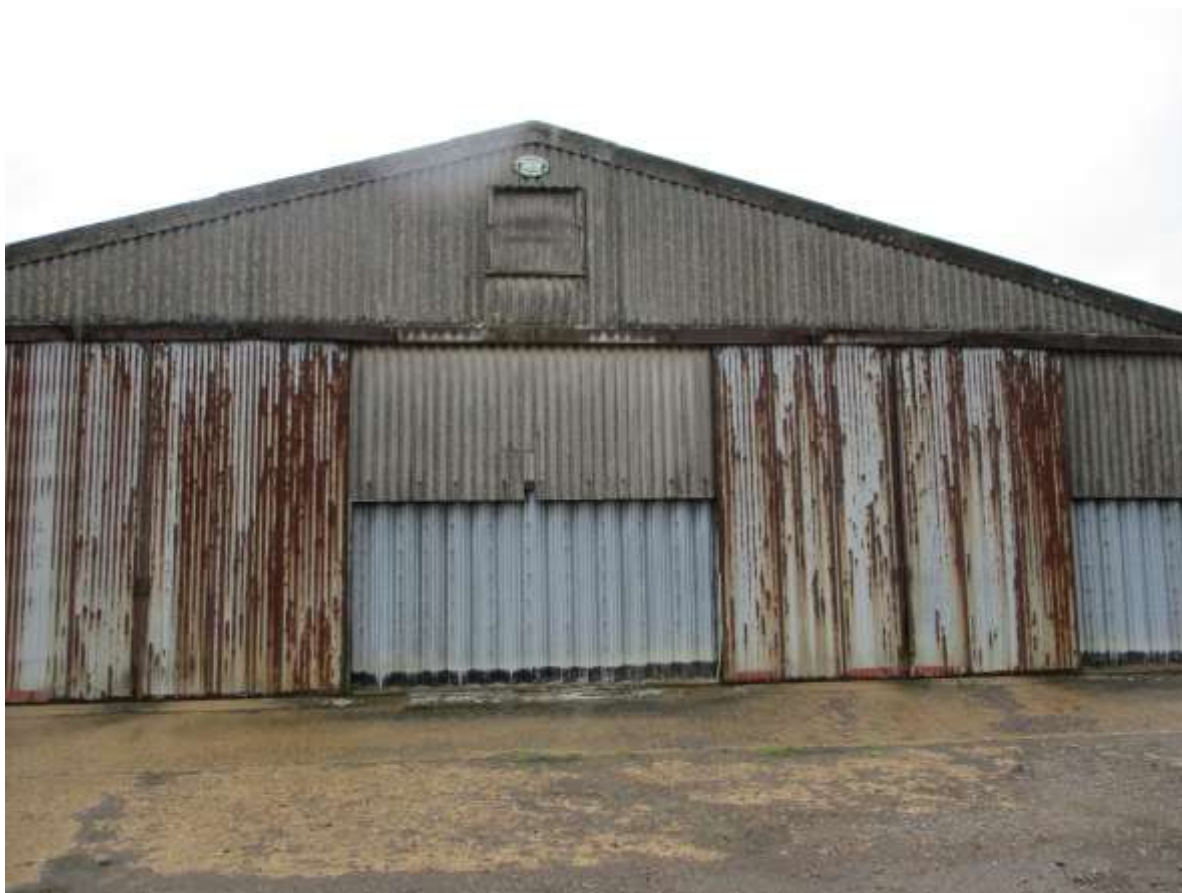
Plate 1: Front elevation.

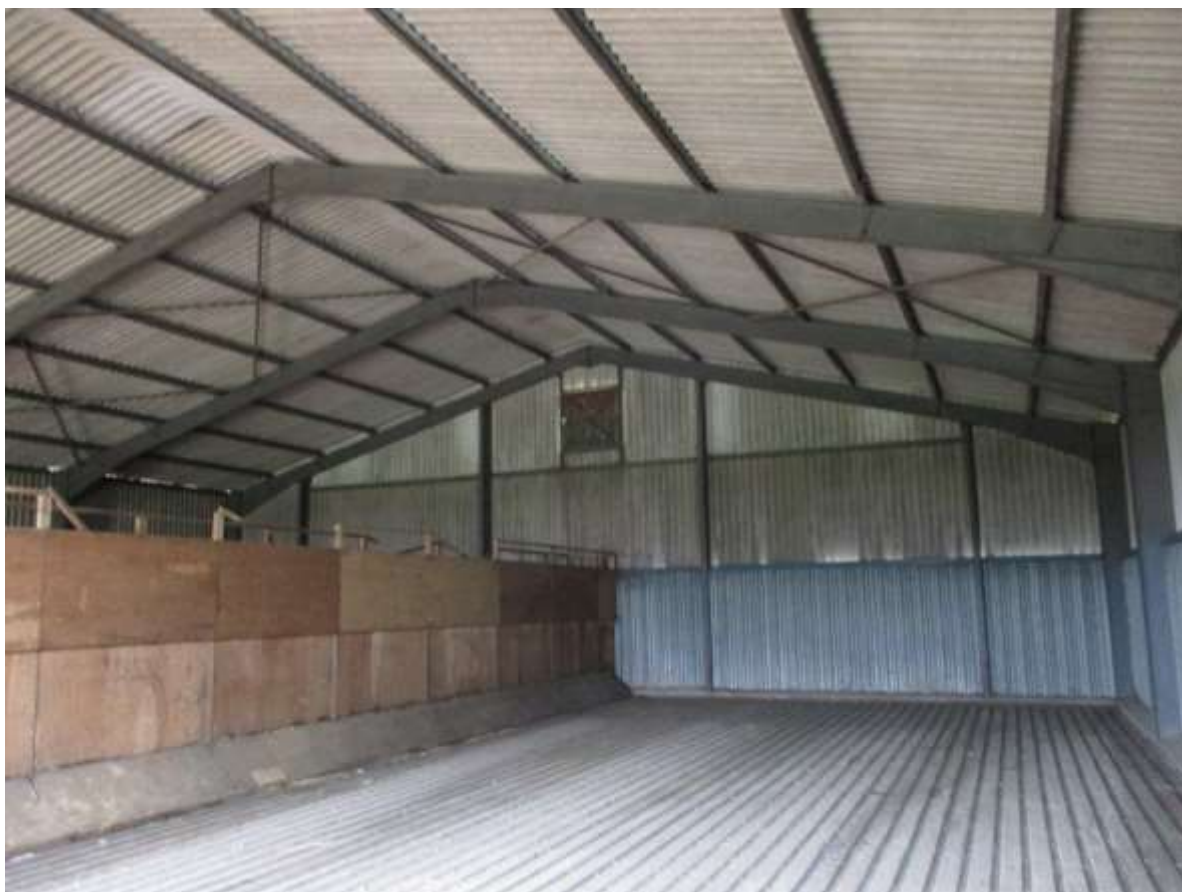
Plate 2: Steel frame.

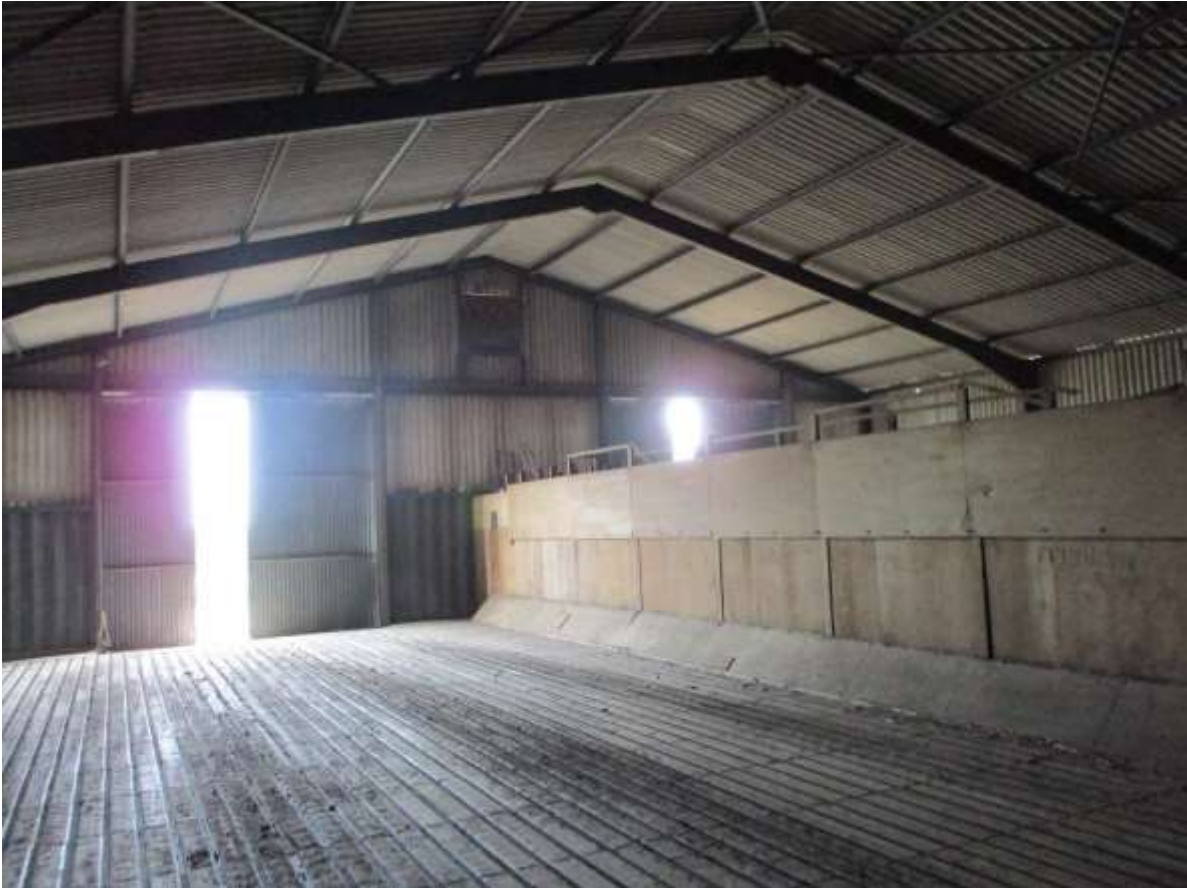
Plate 3: Internal facing main doors.

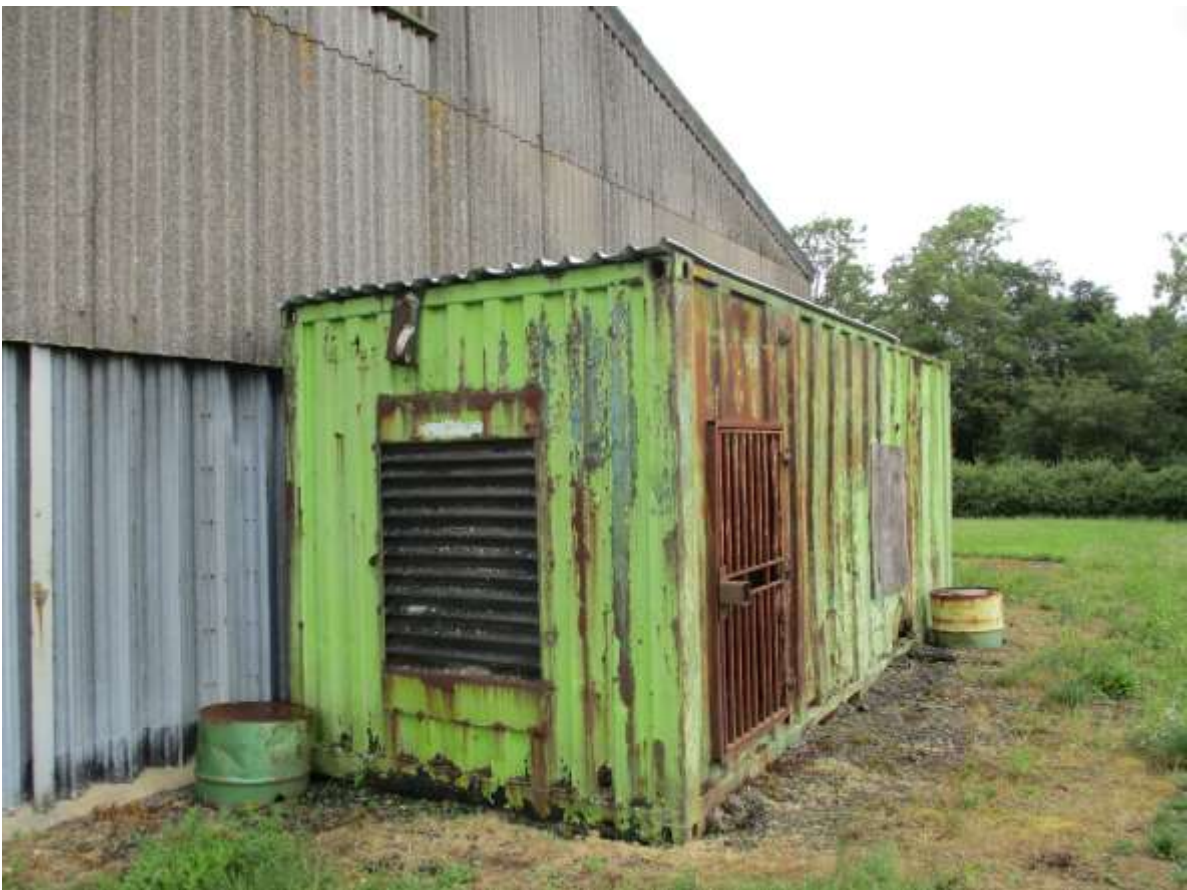
Plate 4: Container at rear.

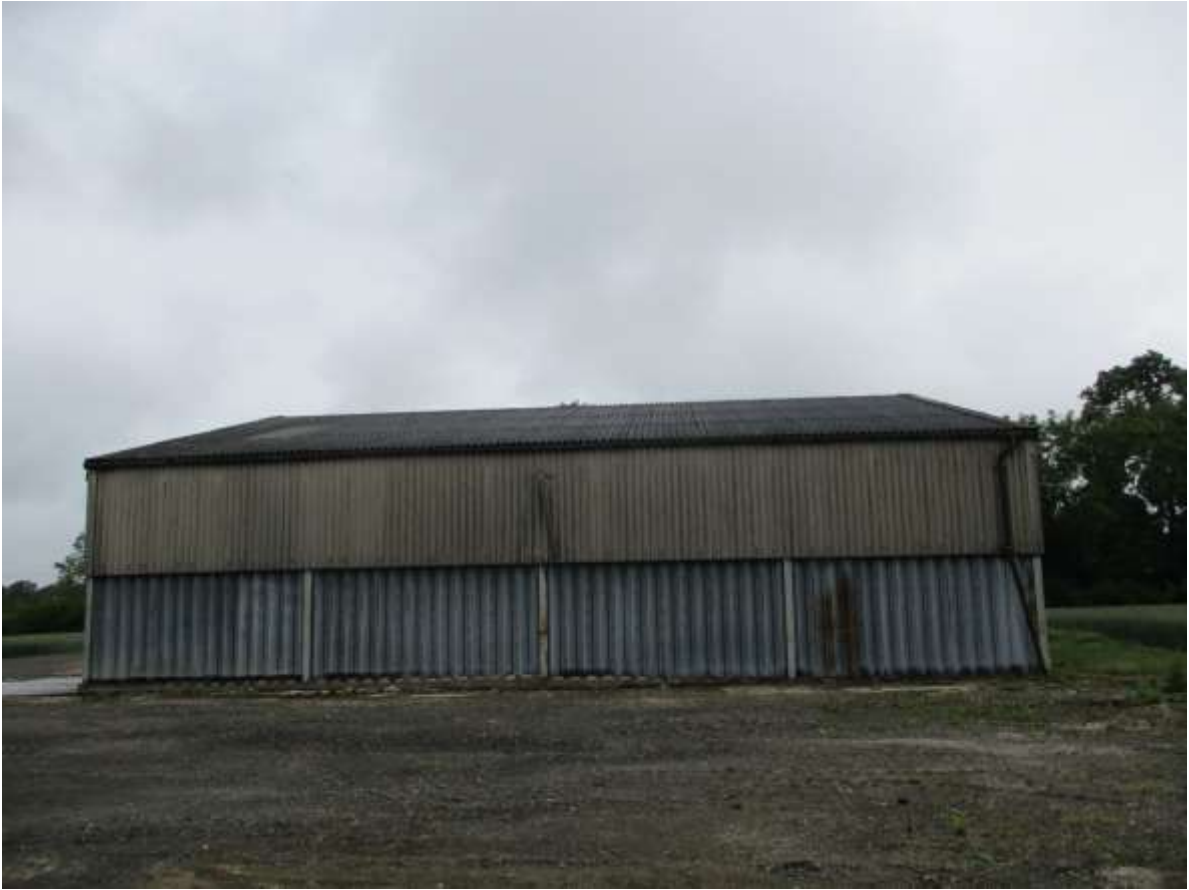
Plate 5: Right-hand elevation.

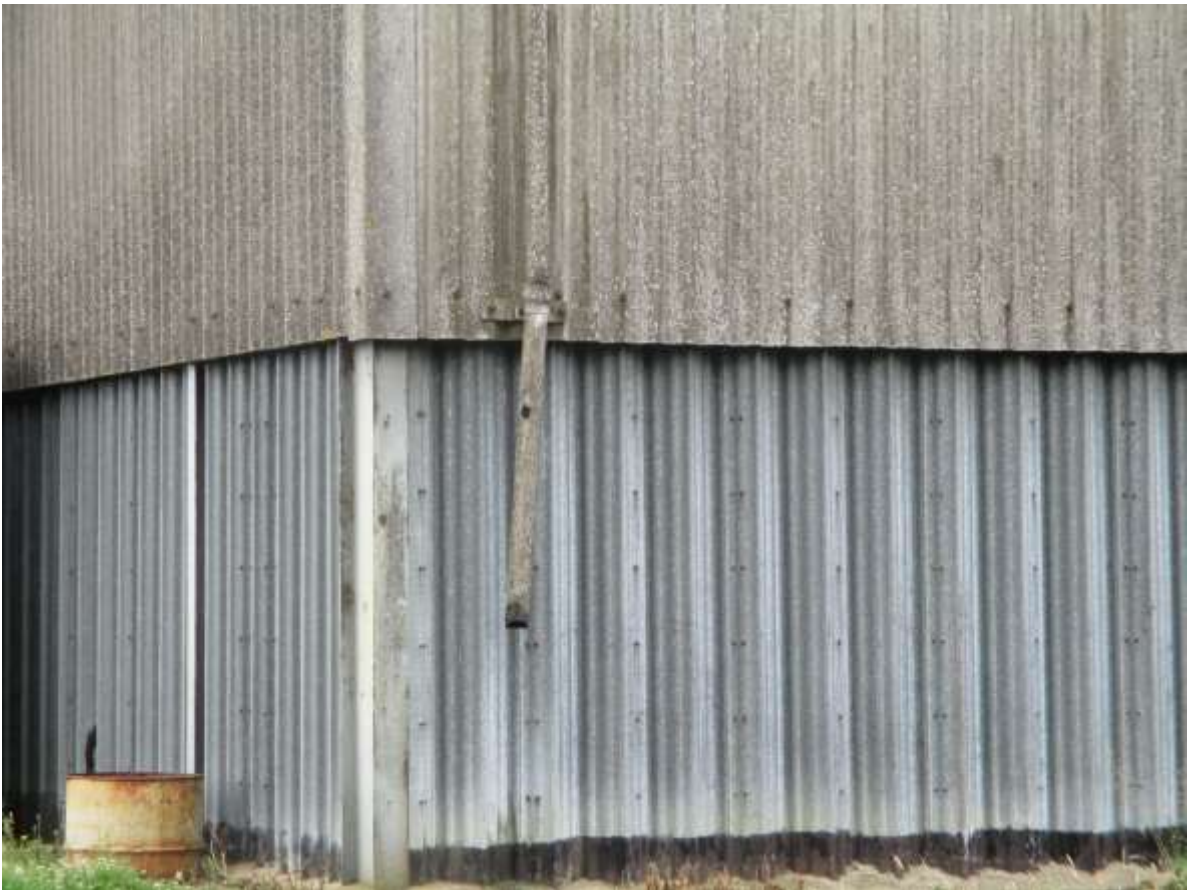
Plate 6: Sections of downpipe missing.

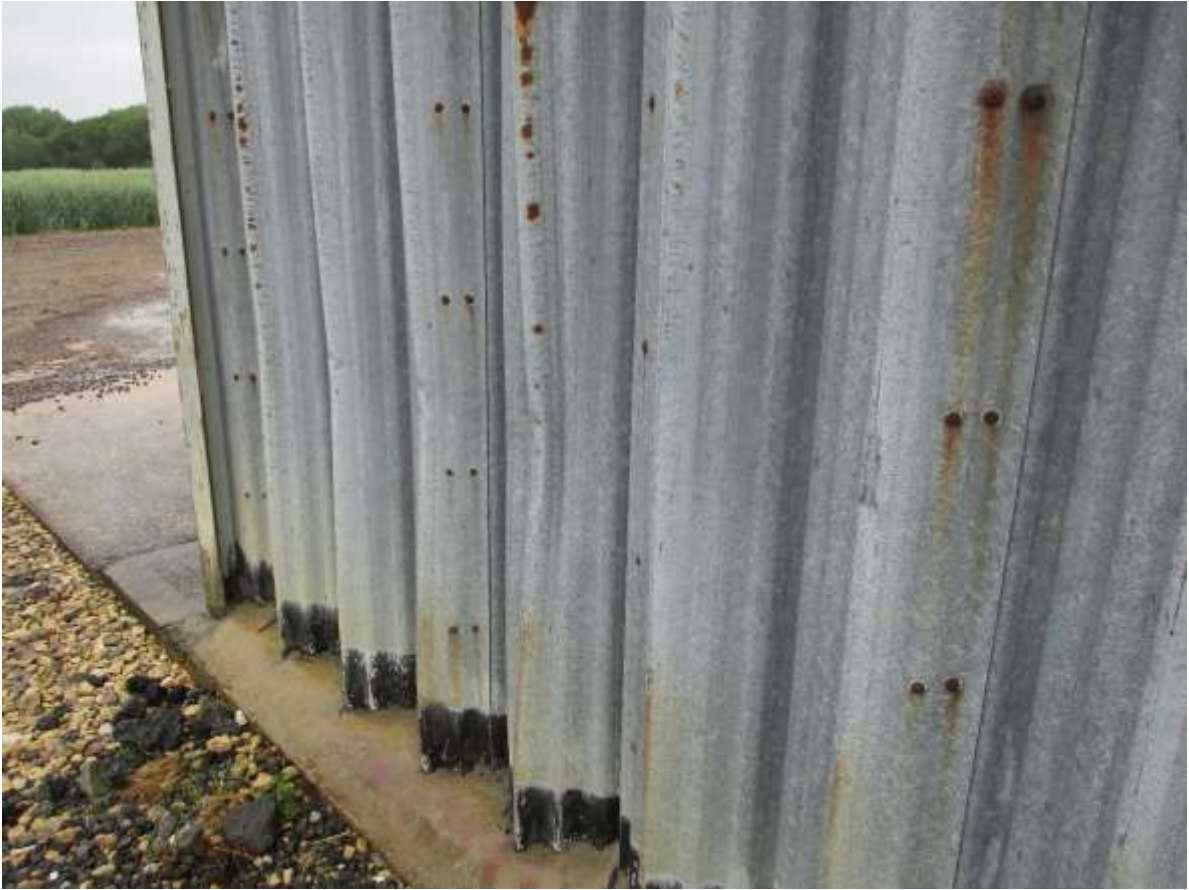
Plate 7: Minor cosmetic impact damage near front corner.

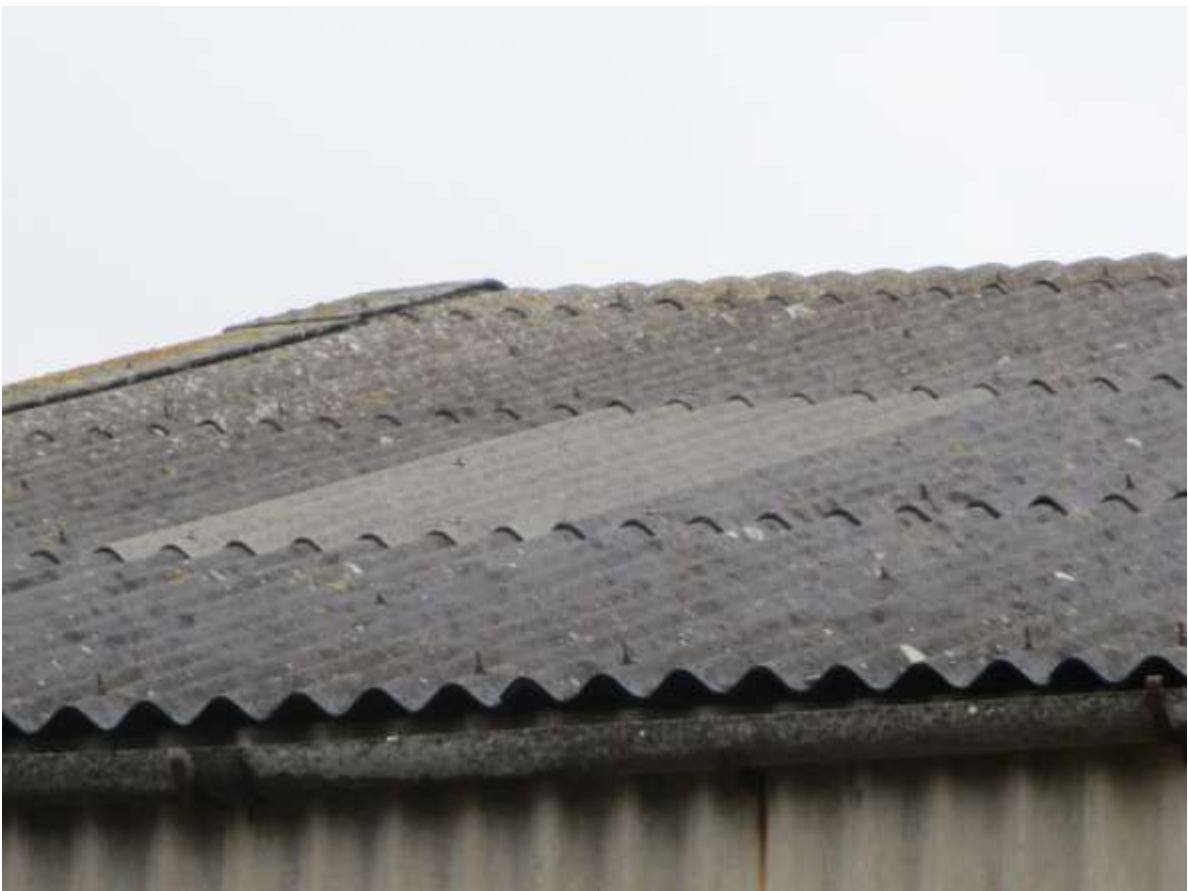
Plate 8: Previous repairs have maintained the barn in good condition.

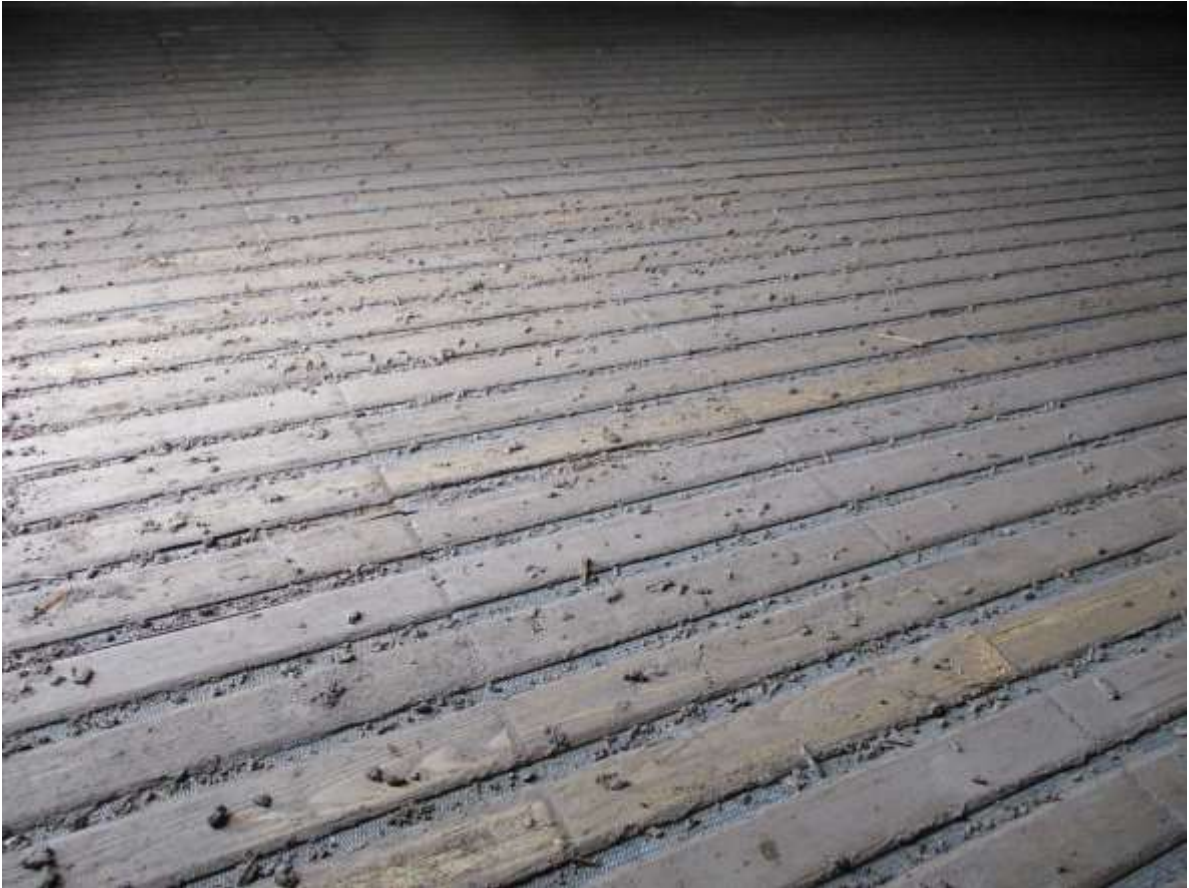
Plate 9: Floor.

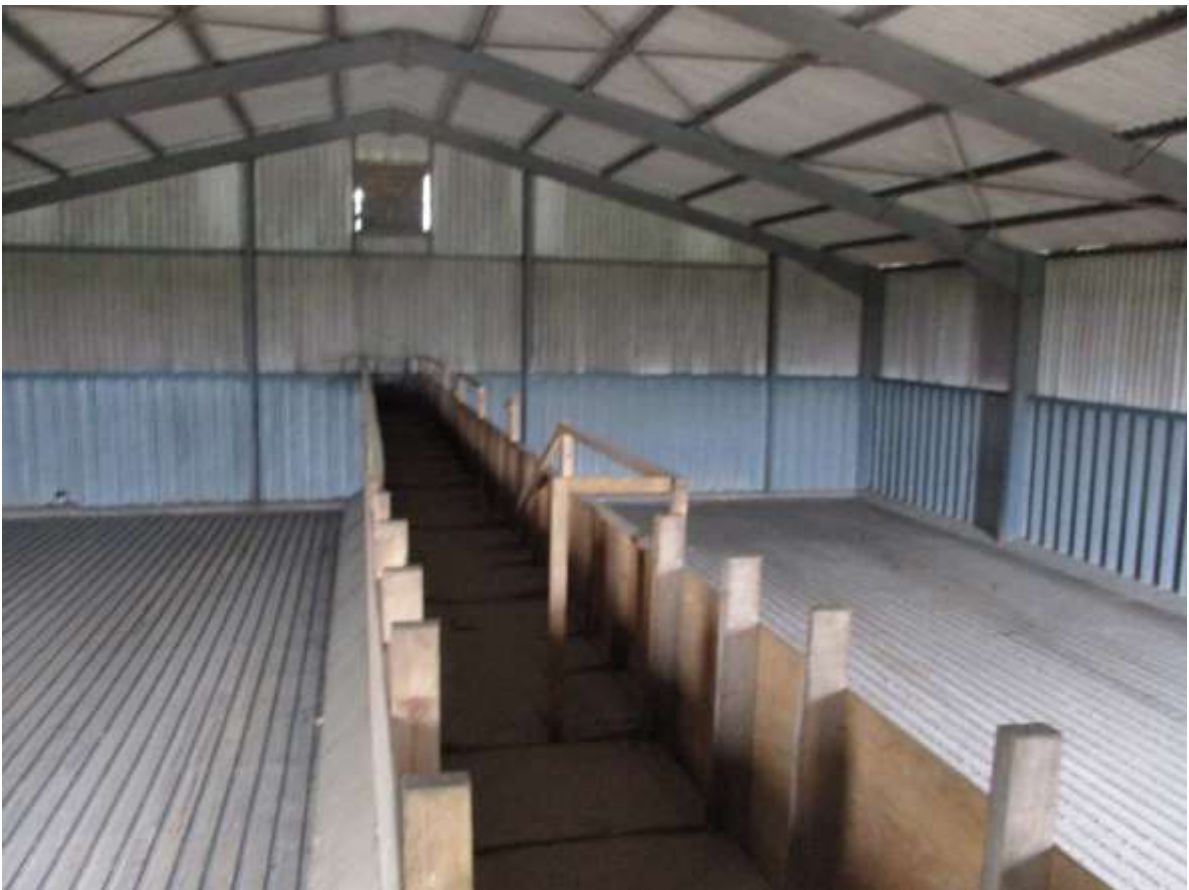
Plate 10: Central structure provides ducting to ventilate storage area.

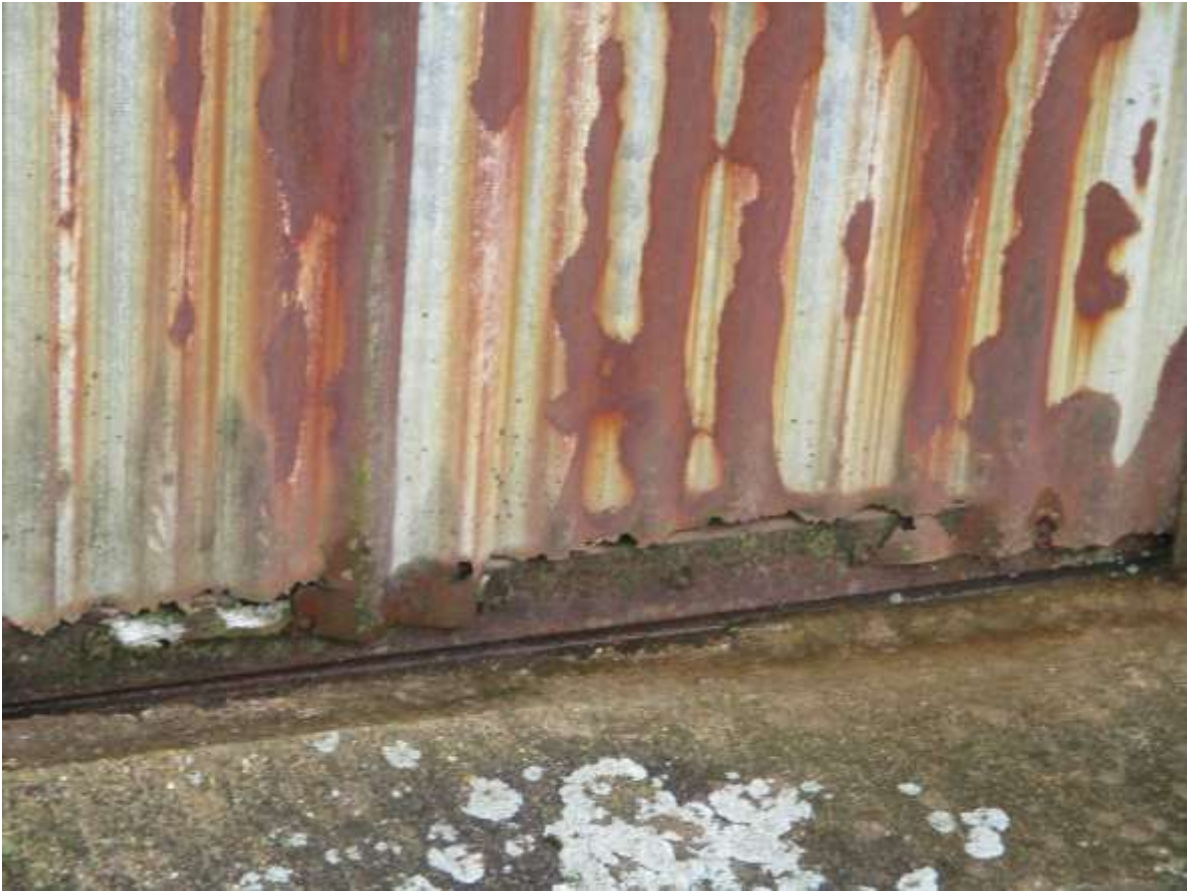
Plate 11: Wear and tear to the main front doors.

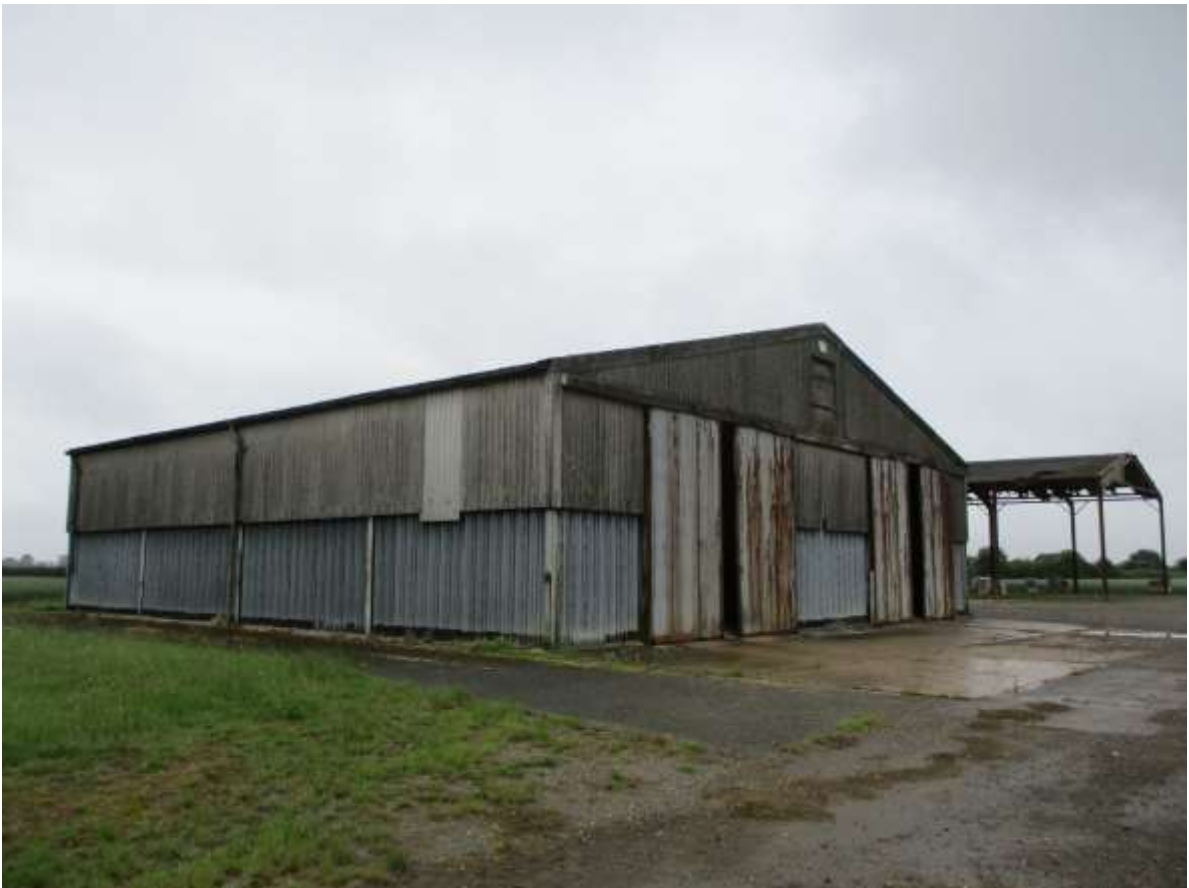
Plate 12: View of barn from gate.
